Bomb Damage Analysis of Alfred P. Murrah Federal Building

By POPEYE

Alfred P. Murrah Federal Building

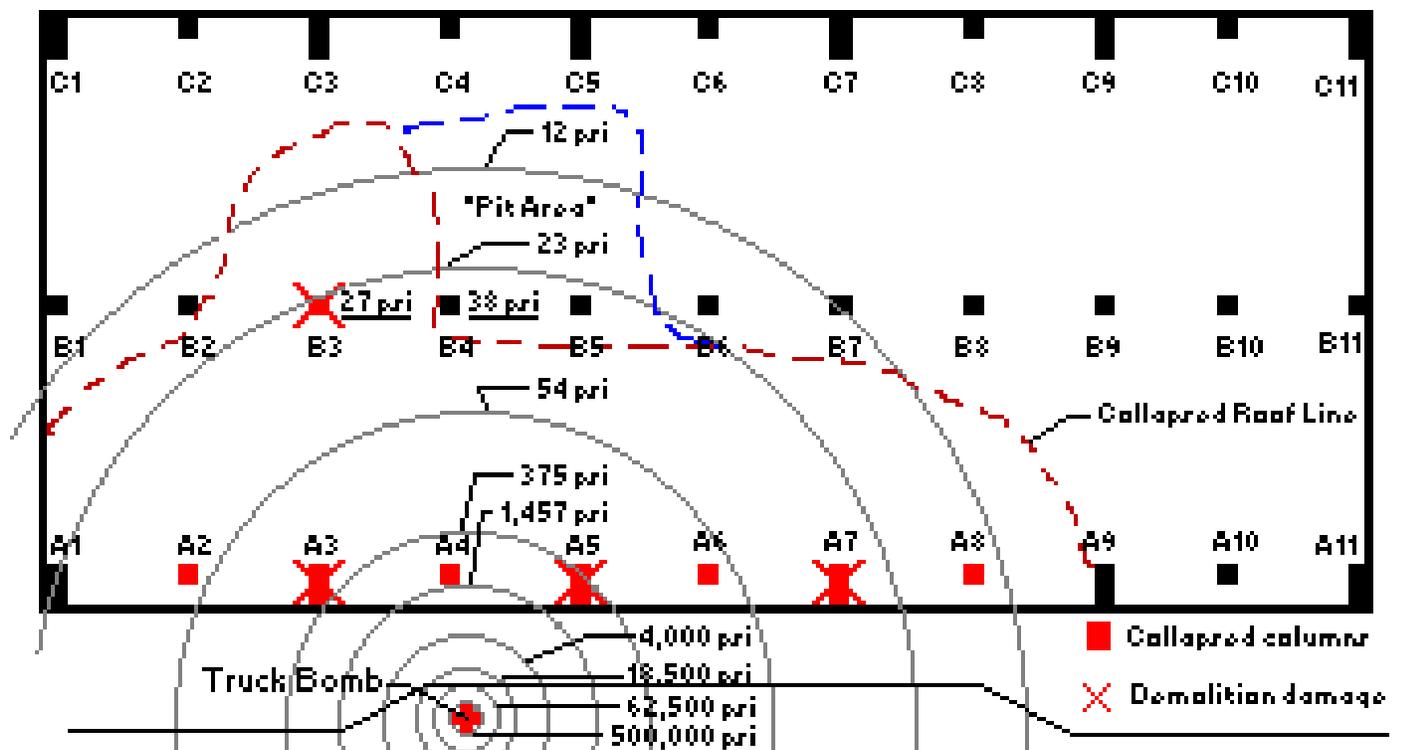
(Brigadier Gen. Bentin K. Partin, USAF – Ret.) On April 19, 1995, the Alfred P. Murrah Federal Building, Oklahoma City, Oklahoma was bombed, causing extensive damage to the structure, the loss of 168 innocent lives, the victimization of the families of those who lost loved ones, hundreds of non-fatal injuries, and substantial property damage in the vicinity. The media and the Executive branch reported that the sole source of the devastation was a single truck bomb consisting of 4,800 pounds of ammonium nitrate, transported to the location in a Ryder Truck and parked in front of the building. It is impossible that the destruction to the building could have resulted from such a bomb alone. To cause the damage pattern that occurred to the Murrah building, there would have to have been demolition charges at several supporting column bases, at locations not accessible from the street, to supplement the truck bomb damage. Indeed, a careful examination of photographs showing the collapsed column bases reveals a failure mode produced by demolition charges and not by a blast from the
